DEPARTMENT OF TRANSPORTATION**DIVISION OF ENGINEERING SERVICES**

Contract #: 04-0120F4Cty: SF/ALA Rte: 80 PM: 13.2/13.9File #: 1.28**WELDING INSPECTION REPORT****Resident Engineer:** Casey, William**Address:** 333 Burma Road**City:** Oakland, CA 94607**Report No:** WIR-028498**Date Inspected:** 27-Sep-2012**Project Name:** SAS Superstructure**OSM Arrival Time:** 700**Prime Contractor:** American Bridge/Fluor Enterprises, a JV**OSM Departure Time:** 1530**Contractor:** American Bridge/Fluor Enterprises, a JV**Location:** jobsite**CWI Name:** Barry Drake**CWI Present:** Yes No**Inspected CWI report:** Yes No N/A**Rod Oven in Use:** Yes No N/A**Electrode to specification:** Yes No N/A**Weld Procedures Followed:** Yes No N/A**Qualified Welders:** Yes No N/A**Verified Joint Fit-up:** Yes No N/A**Approved Drawings:** Yes No N/A**Approved WPS:** Yes No N/A**Delayed / Cancelled:** Yes No N/A**Bridge No:** 34-0006**Component:** OBG**Summary of Items Observed:**

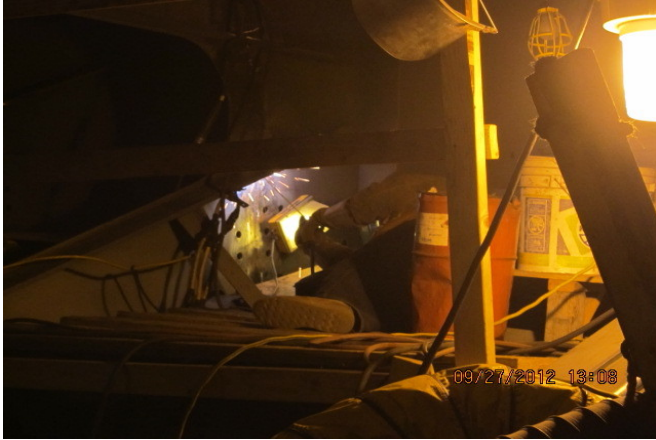
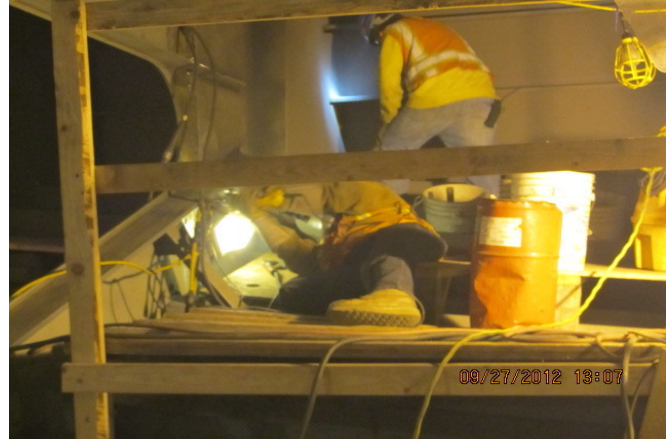
This QAI observed the welder Gue Wu Chan performing first time weld repairs at the following location:

12W-PP115-BW-2

The welder spent part of the shift depositing the root passes and fill passes with approximately 100% being completed at the end of the shift. QC inspector Drake was noted to be present in order to monitor the progress and ensure the welding was within the established Welding Procedure Specification (WPS) noted as ABF-WPS-D15-1001 Rev 0 and supporting Procedure Qualification Records (PQR). Prior to and during the welding at this location the QC inspector observed the preheat temperature using a Raytek non-contact Thermometer, was sufficient and compliant to the above-mentioned WPS. Using a Tempil Stick, (temperature indicating crayon) the pre-heat was then verified by this QA inspector to be greater than 150F. Using a Fluke brand Tong style meter, the parameters were verified to be 130 amps.

12W-PP117-BW-2

The welder spent part of the shift depositing the root passes and fill passes with approximately 100% being completed at the end of the shift. QC inspector Drake was noted to be present in order to monitor the progress and ensure the welding was within the established Welding Procedure Specification (WPS) noted as ABF-WPS-D15-1001 Rev 0 and supporting Procedure Qualification Records (PQR). Prior to and during the welding at this location the QC inspector observed the preheat temperature using a Raytek non-contact Thermometer, was sufficient and compliant to the above-mentioned WPS. Using a Tempil Stick, (temperature indicating crayon) the pre-heat was then verified by this QA inspector to be greater than 150F. Using a Fluke brand Tong style meter, the parameters were verified to be 122 amps.

This QAI observed the welder Jin Pei Wang performing first time weld repairs at the following location:

12W-PP115.5-PS-1
